BOARD OF DIRECTORS' REPORT #44/17

SUBJECT: Gorrie Conservation Area Flood Event Update

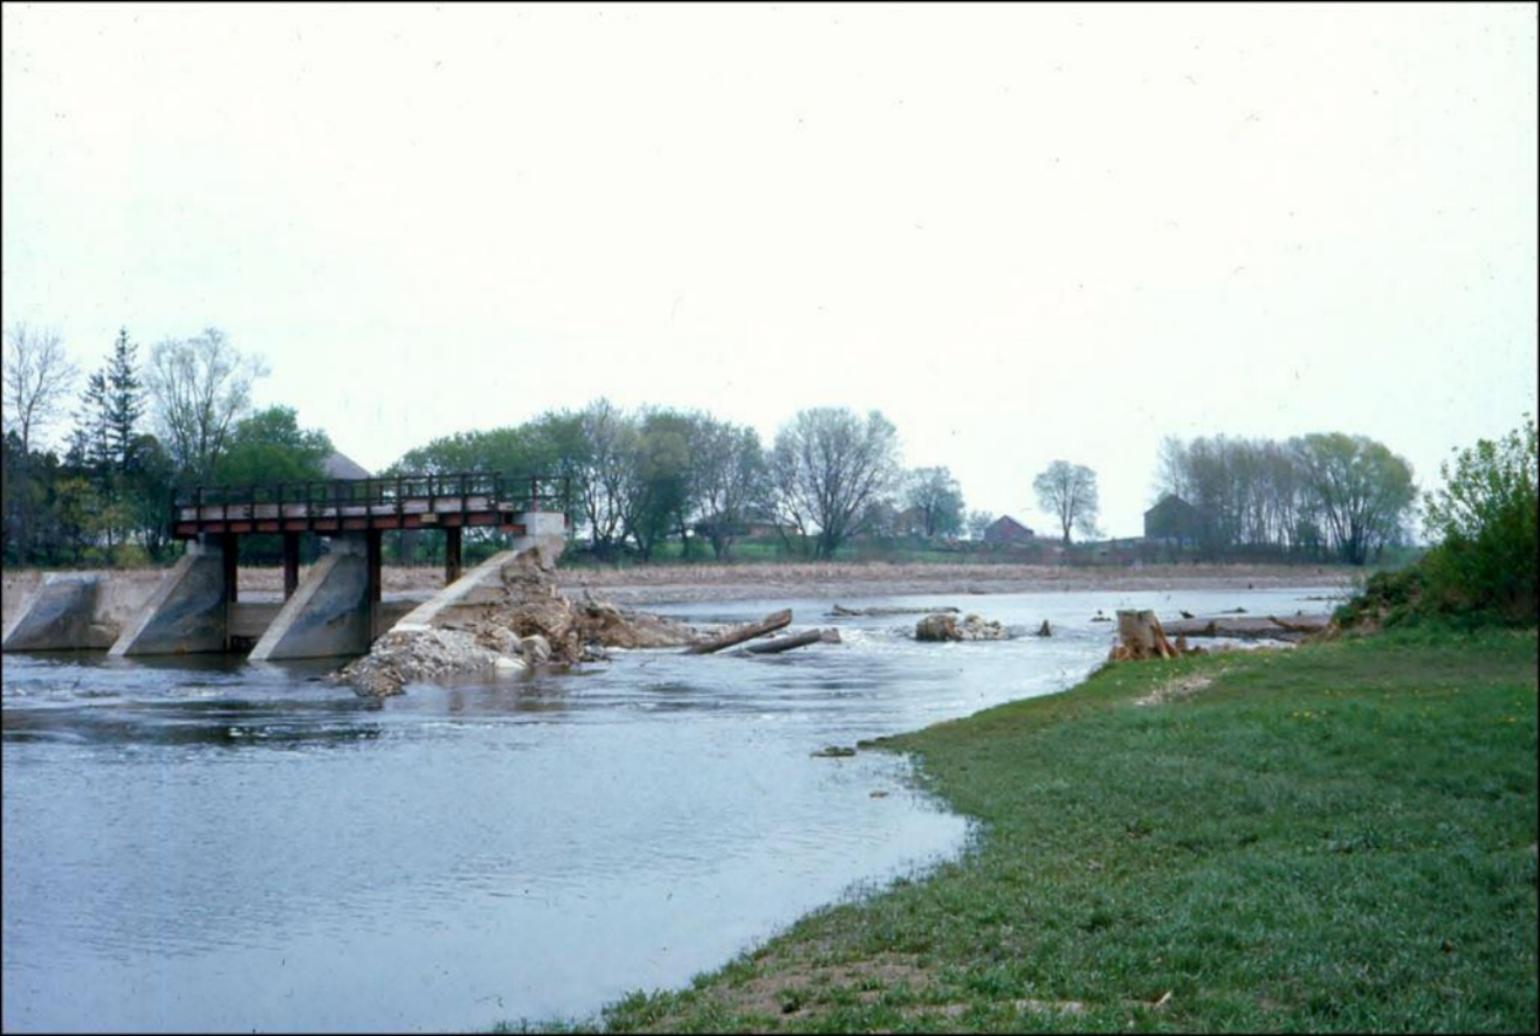
The first shows the damage to the Gorrie Dam after the May 1974 flood.

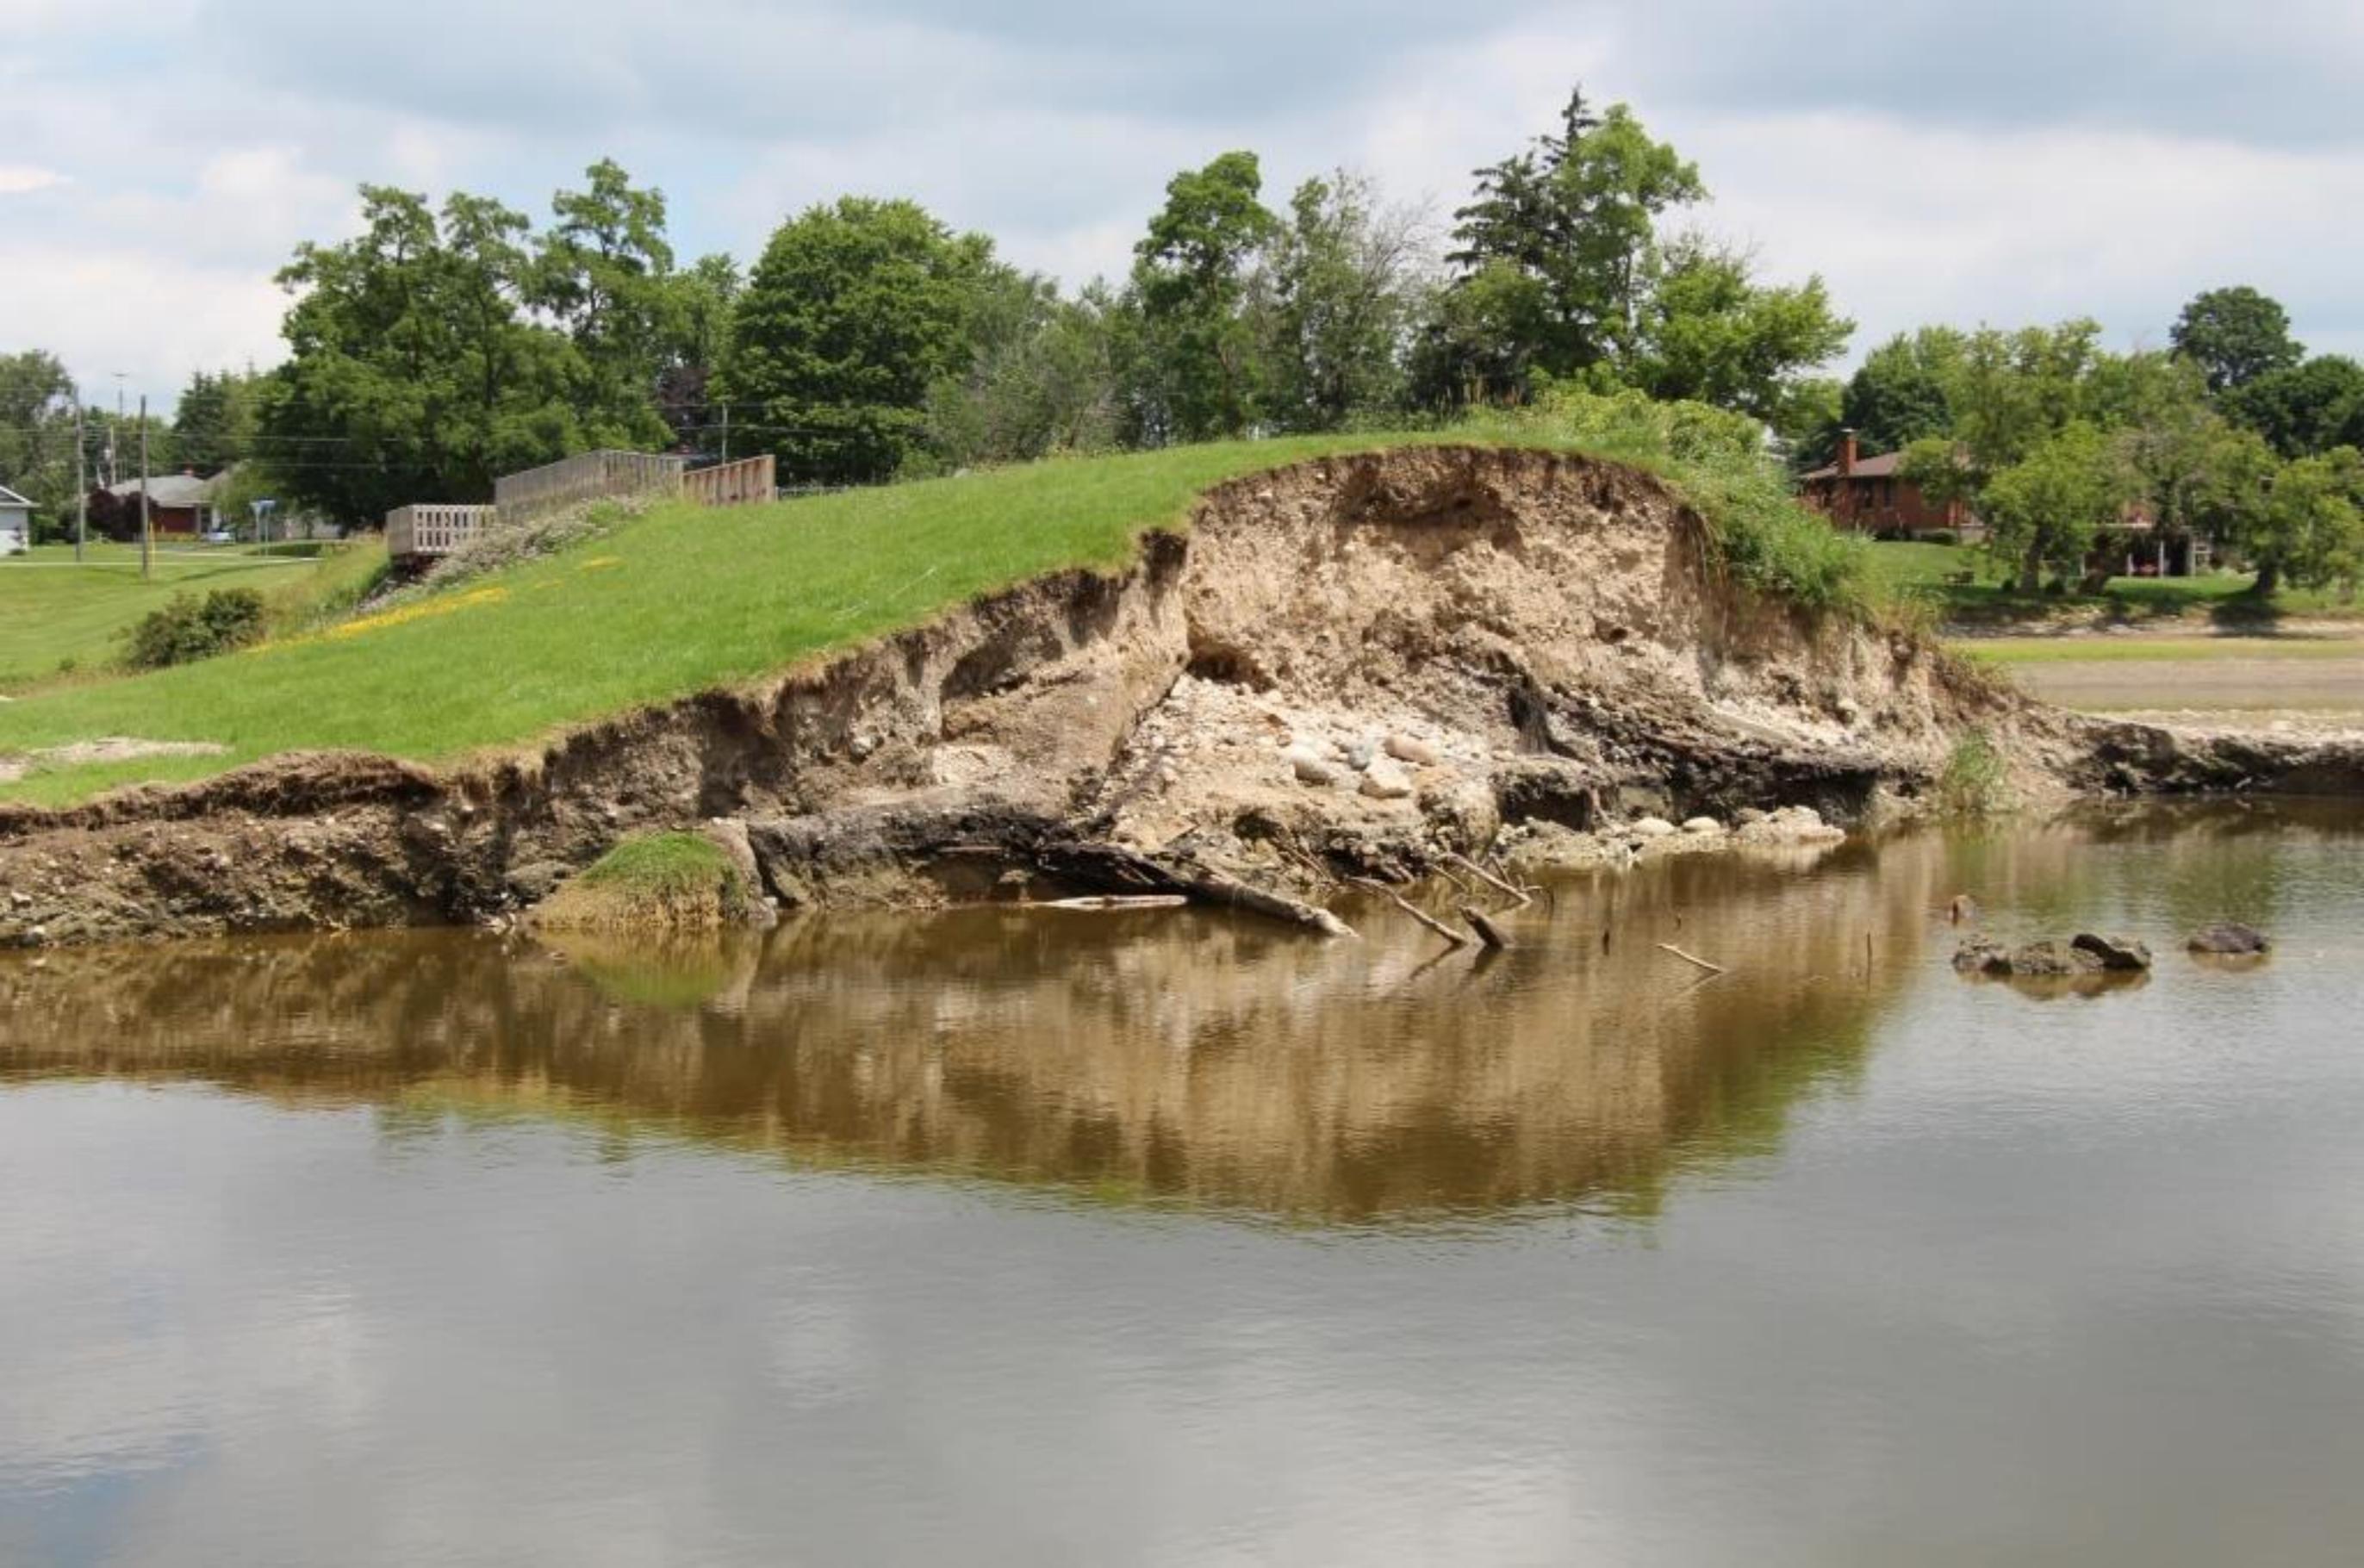
The second shows the damage to the emergency spillway berm after the June 23rd, 2017 flood.

- Complete studies as required- identify flow velocities through the breach in the spillway and design erosion control measures for regraded berms and vegetation

- Engineered plans required for the regrading/stabilization of the exposed sections of the berm, scour hole repair, and mill race repairs (costs unknown at this time)
- Identify the timeframe required for temporary repairs.
- MNRF will require an estimate from MVCA for developing a long term plan for the site.
