Shoreline Sub-basin WATERSHED Report Card 2013

This report describes the conditions of the rivers, forests, wetlands and groundwater in the Shoreline Sub-basin watershed. It is one component of the Maitland Valley Conservation Authority's (MVCA) overall watershed report card that assesses the same indicators. The Shoreline Maitland River is one of seven major sub-basins that comprise the Maitland watershed.

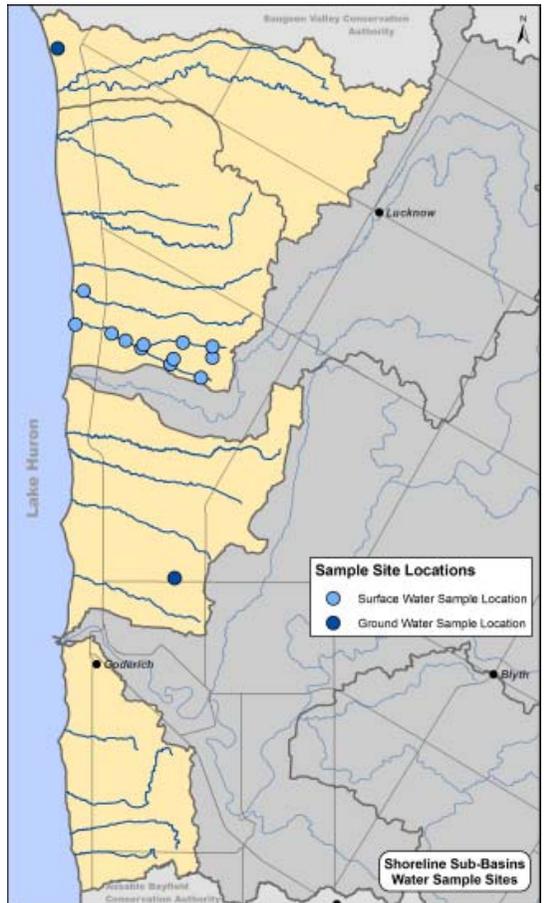
Water Quality Results

Surface Water Indicators	Shoreline 2007-2011 Results	Shoreline Grade 2007-2011	Overall MVCA Grade 2007-2011
Phosphorus	0.0386 mg/L	C	B
Benthics	6.45	D	B
E.coli	202,499 cfu/100ml	C	C

Groundwater Indicators	Middle Maitland 2007-2011 Grades	Overall MVCA Grade 2007-2011
Nitrate + Nitrite	A	A
Chlorid	A	A

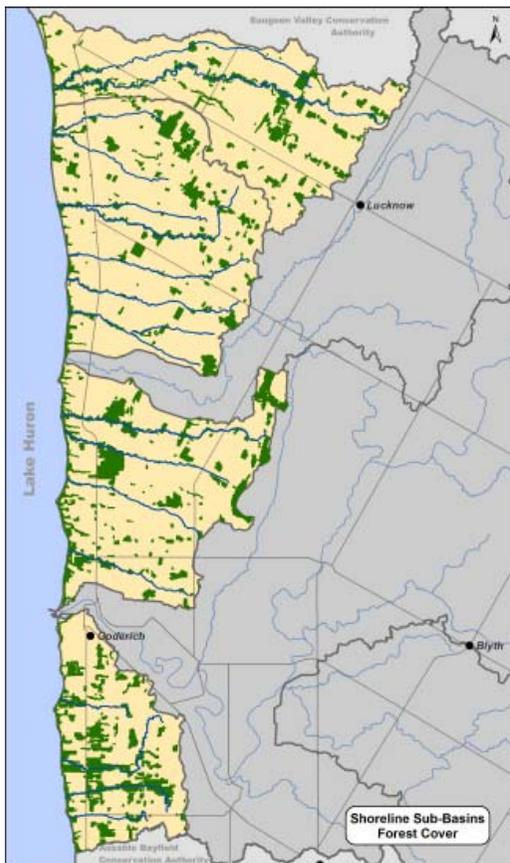
Forest and Wetland Results

Forest Condition Indicators	Shoreline 2007-2011 Results	Shoreline Grades 2007-2011	Overall MVCA Grades 2007-2011
Forest Cover	12.47 %	D	C
Forest Interior	2.12 %	F	D
Riparian Cover	34.78 %	C	C

Wetland Indicator	Shoreline Grade 2007-2011	Overall MVCA Grade 2007-2011
% of area identified as wetland	D	C
