South Maitland River Sub-basin

Report Card 2013

This report describes the conditions of the river, forests and wetlands in the South Maitland River watershed. It is one component of the Maitland Valley Conservation Authority's (MVCA) overall watershed report card that assesses the state of surface water, groundwater, forests and wetlands. The South Maitland River is one of seven major sub-basins that comprise the Maitland watershed.

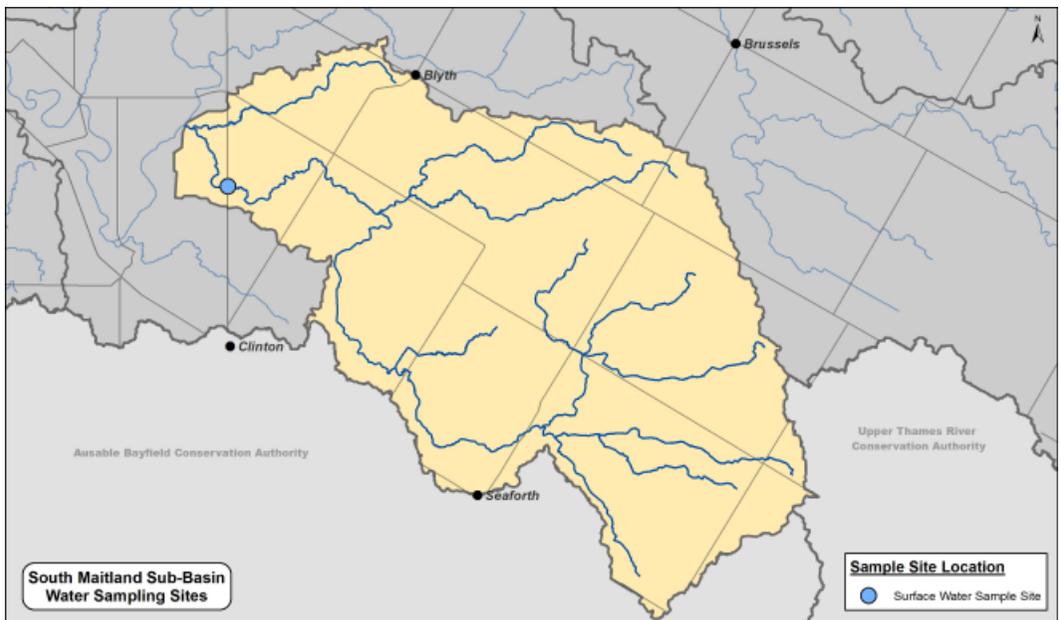
Surface Water Indicators	South Maitland 2007-2011 Results	South Maitland Grade 2007-2011	Overall MVCA Grade 2007-2011
Phosphorus	.027 mg/L	B	B
Benthics	5.73	C	B
E.coli	93.337 cfu/100ml	B	C

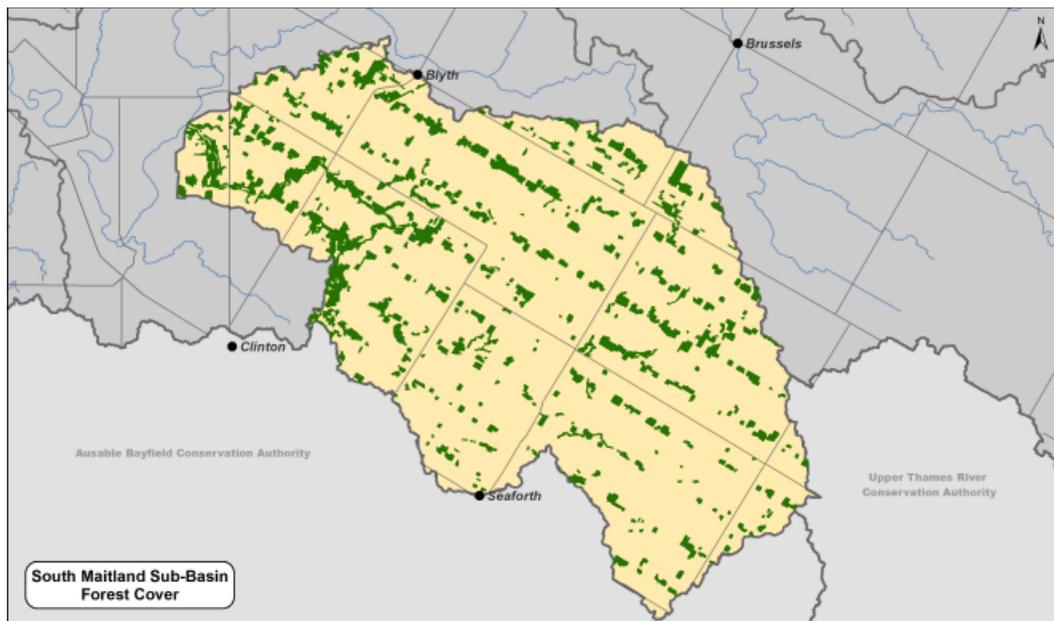
Forest Condition Indicators	South Maitland 2007-2011 Results	South Maitland Grades 2007-2011	Overall MVCA Grades 2007-2011
Forest Cover	7.99 %	D	C
Forest Interior	0.85 %	F	D
Riparian Cover	16.25 %	D	C

Wetland Indicator	South Maitland Grade 2007-2011	Overall MVCA Grade 2007-2011
% of area identified as wetland	D	C

- Creating more natural infrastructure including forested areas, buffer strips, windbreaks and wetlands to protect the land from extremes of heat, wind and runoff.
- Planting trees. This sub-basin continues to have the lowest scores for both forest cover and forest interior. There is a significant need to plant trees throughout the sub-basin and to extend forest edges to create more interior areas.
- Protecting existing forest cover and wetlands. Wetlands are regulated areas. Landowners should contact the MVCA before undertaking any projects near a wetland or watercourse.
- The high number of permanently flowing streams indicates that there is the potential to undertake stream enhancement work including buffer strips and habitat improvements.
- Increase residue cover and organic matter on fields.
- Ensure proper applications of manure, fertilizers and pesticides.
