What's Up Along the **LAKE HURON** Shoreline?

June 2020

LAKE HURON WATER LEVELS

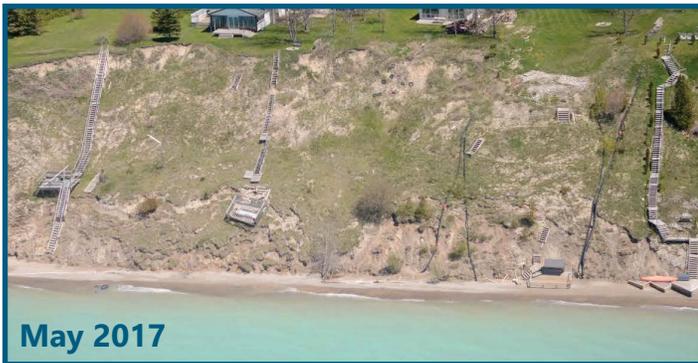
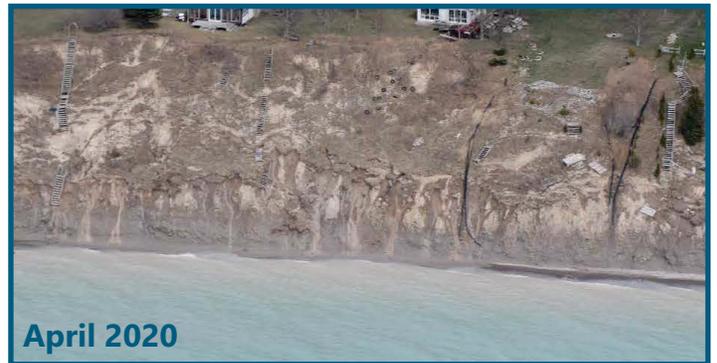
EXAMPLE of RECENT EROSION

Bluff erosion is a serious concern because it places structures and life at risk. Toe erosion destabilizes the bluff and leads to top-of-bluff recession. Erosion at the top of the bluff may occur in one large failure or in many smaller failures. Unfortunately there is no way to predict the exact timing of these failures.

Maitland Conservation recommends that landowners check their shoreline property, when possible, to look for signs of erosion. Bent or leaning trees, lack of vegetation on the slope, slumping, overland flow and groundwater seepage are all signs that your property is in an area of erosion. If you see a crack running parallel to the shoreline, please contact Maitland Conservation as it is a sign that a failure will occur.
